Support bearing in flap operating mechanism (with and without flap/aileron interconnection system).

PIK-20 and 20 B models, all serial numbers.

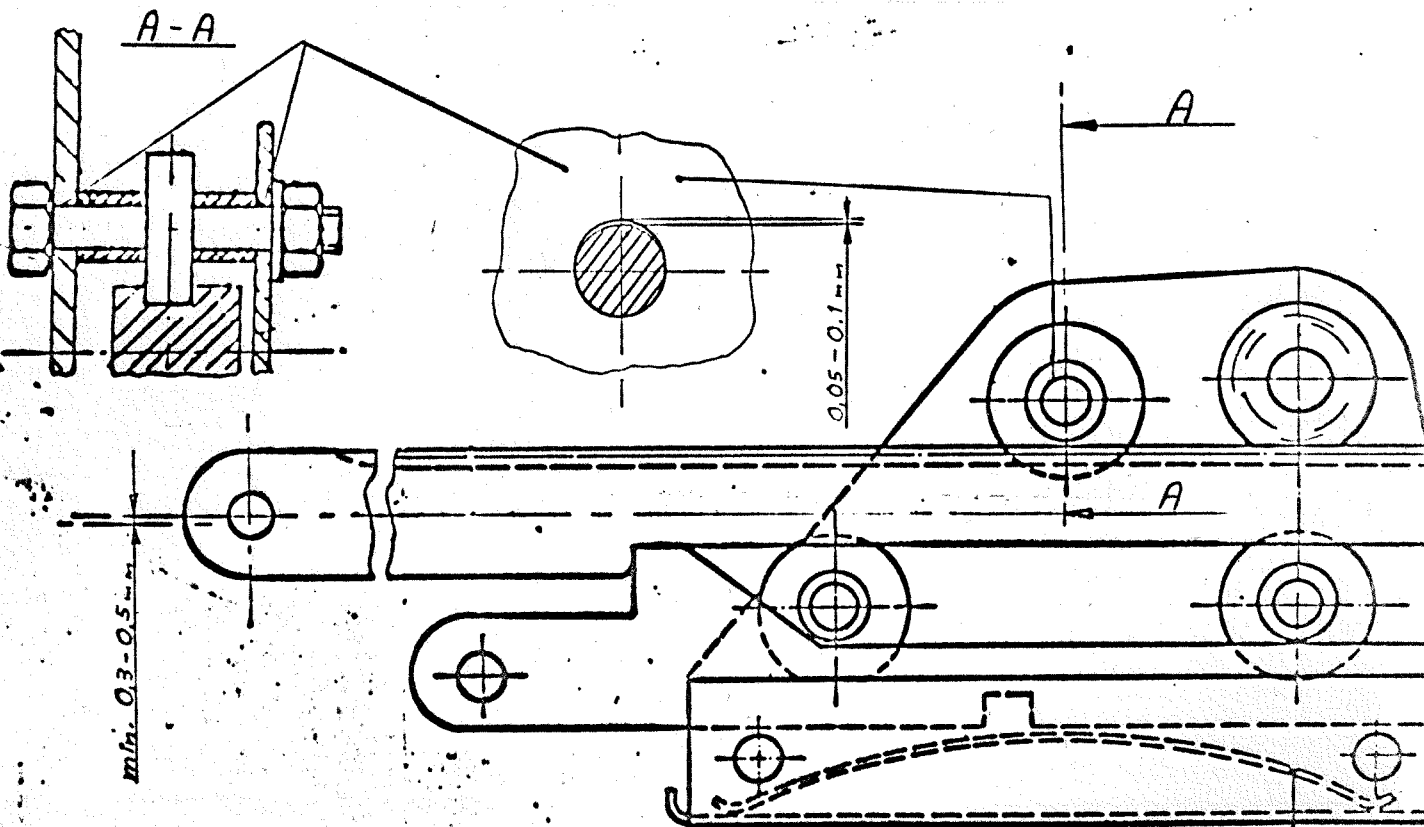
(See fig. 1)

There has been some support bearing failures due to dirt on gear rack and too small tolerance between bearing and rack (See fig. 1). The broken bearing particles may lock the flap control.

1. Detach the flap push rod from the gear rack.
2. Check the free play of the gear rack with all deflections. The play must be min. 0.3 - 0.5 mm depending on the deflection. It is smallest at +90° flap setting.

3. If there is play enough at all deflections, no further action is required.
4. If there is no play at any deflection, the operating mechanism must be detached (See Service Bulletin M 12 June 4, 1976 Instructions 1 to 2) and all dirt removed from the gear rack.
5. If there is still no play the rack must be detached. See M 12 instructions 3 to 4.
6. File about 0.05 to 0.1 mm carefully away from the support bearing axle holes in side plates (with fine ϕ 5.0 mm to 5.5 mm file). See fig. 1. Check the result with the bolt.
7. Change the support bearing type NSK or SKF 626 2Z.
8. Assemble the mechanism (See M 12 instructions 9 to 10).
9. Check the free play.
10. Continue according to M 12, instructions 11 to 13.

NOTE: Do not use any grease on the gear rack.
