MUUTOSTIEDOTE

N 17

Uumalevyn liimaus siivissä.

PIK-20 D purjelentokoneet sarjanumerot
20510...20532 ja 20534 sekä 20542, 20543,
20544, 20548, 20552, 20555 ja 20556.

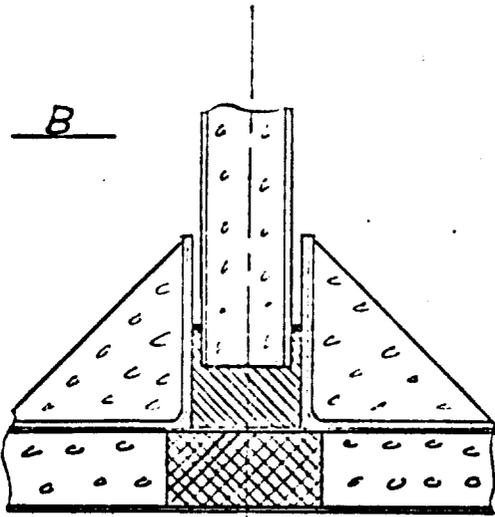
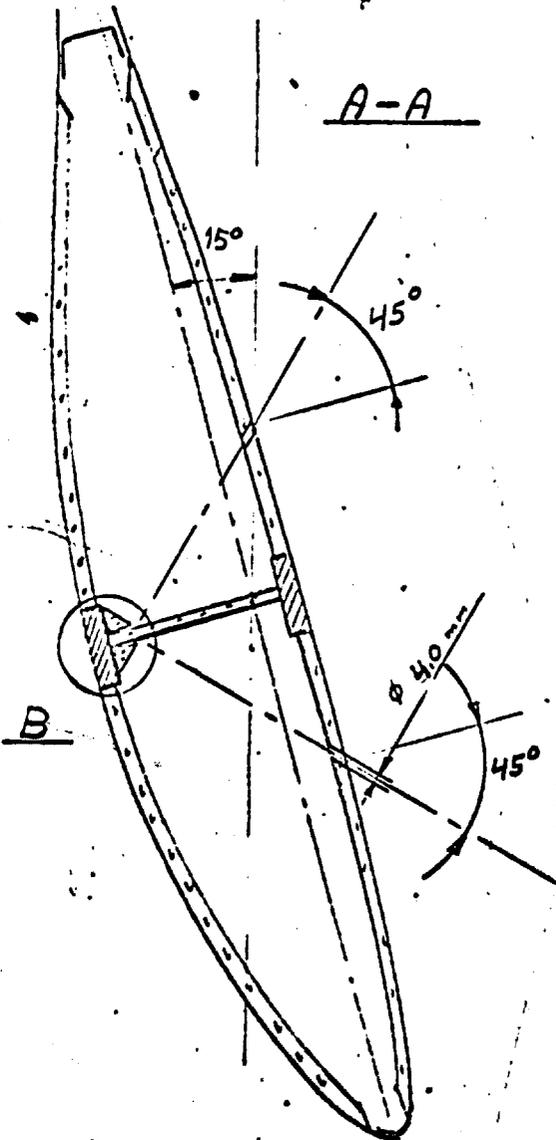
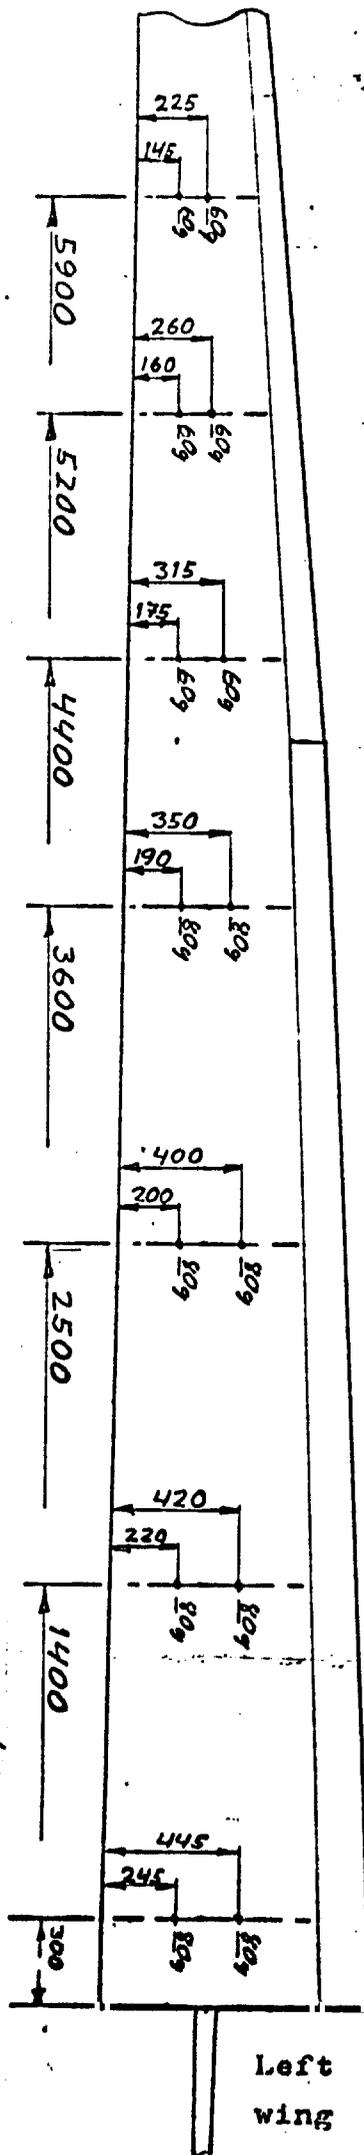
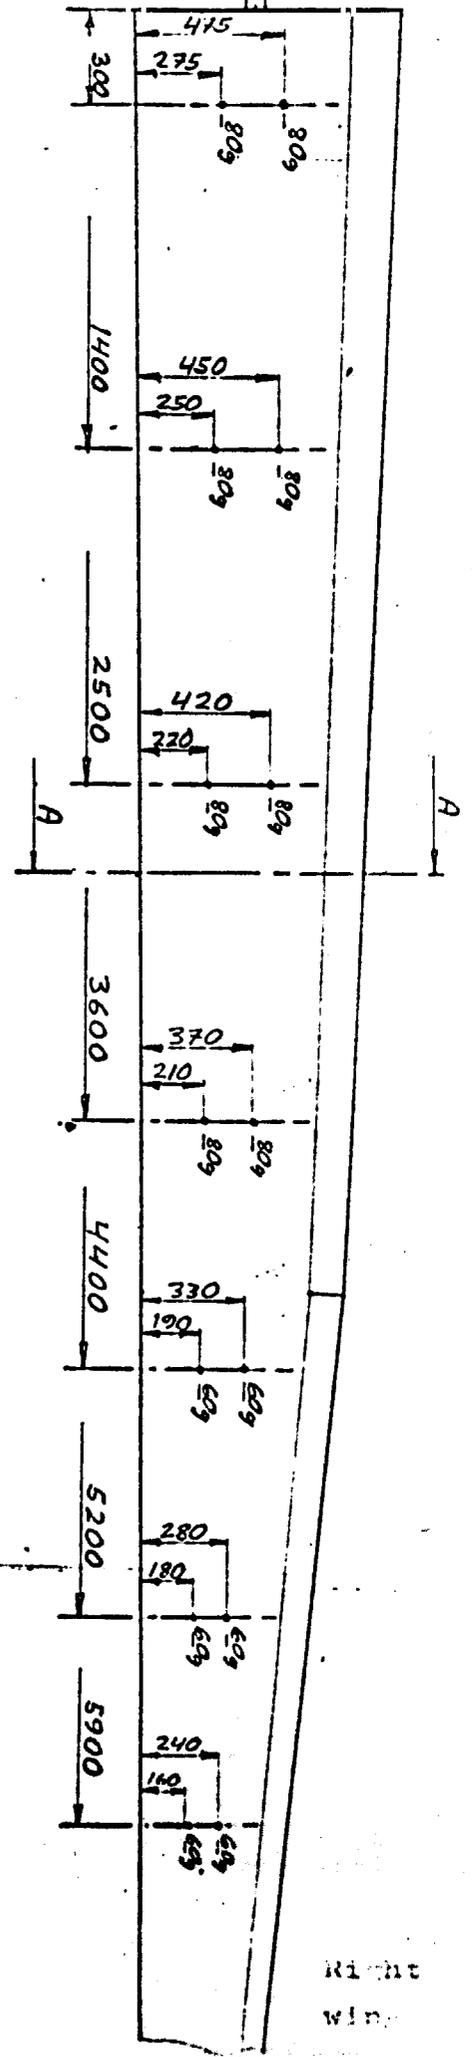
Fig. 1

Valmistaja epäilee, että kyseisissä sarjanu-
meroissa on väärä uumalevyn ja siipisalon
yläpaarten välinen liimasauma johtuen työ-
kalumuutoksesta sarjanumeron 20509 jälkeen
aiheuttaen sen, ettei uumalevy mennyt riit-
tävän syväälle U-muotoiseen liimauskanavaan,
joka on täytetty puoliksi liima-aineella.

The bonding line is found from the average measures given in Fig. 1. The wing is easiest to be supported from the root spar with a giamb and wedge and from the tip leading edge.

Because the inspecting of bonding line is difficult, the rebonding of all mentioned serial number wings shear web main bonding is recommended

1. Remove the water ballast tanks (See PIK-20 D Repair Manual page III - 12).
2. Remove the sealing thunnels at main rib.
3. Inspect if there is water still in the wing, if there is, dry it by using vacuum cleaner outl air min. 6 hours through the water ballast tank opening in the main rib. (Wing must be in normal position and the water ballast opening sealed around the hose.)
4. Wax the lower surfaces with car wax containing no silicon.
5. Drill the ϕ 4 mm holes according to Fig. 1. Be sure about 45° degrees tilting.
6. Support the wing 15 degrees tilted from vertical position nose down. The upper surface bonding line must be absolutely horizontal. Check it by measuring from the floor.

9. Put the ϕ 4 mm needle through the ti,most upper hole. Try to reach the web and PVC foam corner and then pull the needle 10 mm backward and spray 60 g of mixed resin on the shear web about one minute. Continue with the next two holes. Then inspect if there is any resin leakage which can be seen with the lamp through water ballast opening. If there is, put a sign on the wing.
